Fan Bearing Maintenance & Troubleshooting

TWIN CITY FAN & BLOWER | WWW.TCF.COM

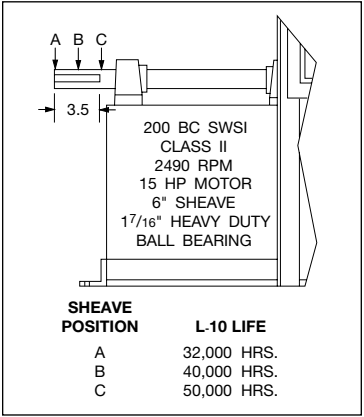
Figure 1 shows a typical fan selected to use a sheave with a six inch diameter on the fan shaft. With the sheave mounted at the end of the shaft, as far away from the bearing as possible, the L-10 life calculates to be 32,000 hours. (See FE-1200 for an explanation of L-10 life.) By moving the sheave 1.25" closer to the bearing, the life is increased to 40,000 hours. When the sheave is moved in another 1.25" so that it is as close to the bearing as possible, the life increases to 50,000 hours. The lesson learned by this example is to maximize bearing life by mounting the sheave as close to the bearing as possible.

Figure 1. Effect of Sheave Location on Bearing Life

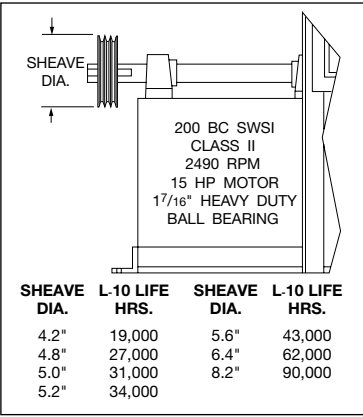
Most belt drives are selected using computer programs. The user puts in the information and the computer selects several sheave and belt combinations that will work and usually highlights the least expensive. But the combination selected has a significant effect on bearing life. Large sheaves result in less belt pull and longer bearing life. Figure 2 shows the L-10 life for different fan sheave diameters. All of them are viable drive selections. The L-10 life varies from 19,000 hours with a 4.2 inch diameter sheave, to 90,000 hours with an 8.2 inch diameter sheave. Avoid the selections with the smallest sheave sizes. They are probably not the least expensive anyway since they require more belts. The best drive selection is one with a reasonable sheave size and moderate cost.

Figure 2. Effect of Sheave Diameter on Bearing Life

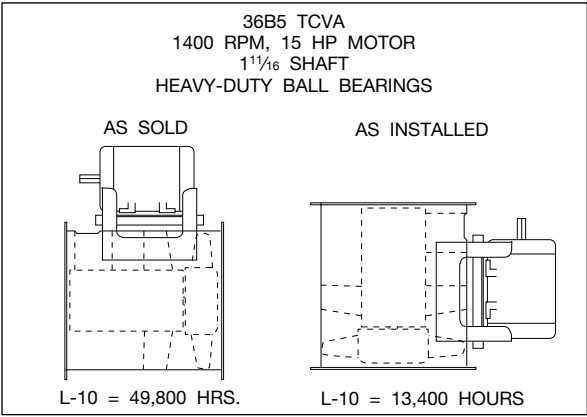
Fan orientation affects bearing life. A fan designed to operate with its shaft positioned horizontally will have a lower bearing life when positioned with a vertical shaft. This is due to the additional thrust loads put on the bearings from the shaft and impeller weight. Figure 3 shows an example. An axial fan designed for horizontal duty has an L-10 life of 49,800 hours. Tipping the fan so that the shaft is vertical lowers the bearing life to an unacceptable level of 13,400 hours. If a fan is to operate with a vertical shaft, make sure to order it for this orientation.

Figure 3. Effect of Shaft Position on Bearing Life

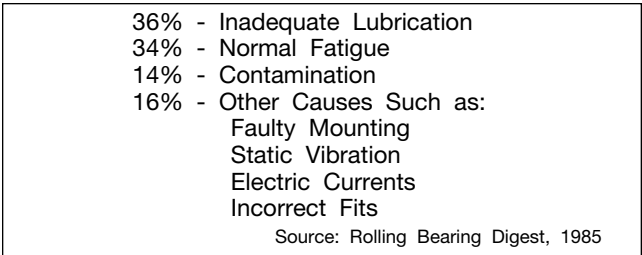
The L-10 life discussed earlier is an estimate of the fatigue life of a bearing. However, there are many other factors that determine how long a bearing lasts. Figure 4 shows the results of one study that looked at the reasons for bearing failure. What is interesting about this study is that it shows that normal fatigue is not the normal cause of bearing failure, since only 34% of the bearings failed this way. Half of the bearing failures were due to either inadequate lubrication or contamination. Other sources list fatigue to be the cause of only 10% of bearing failures.

Figure 4. Bearing Failure Causes

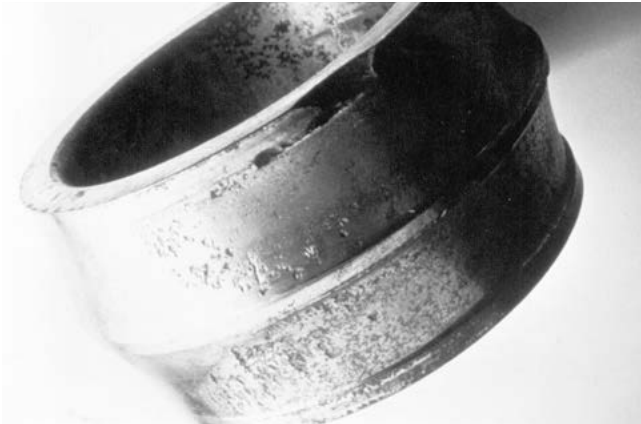
Figure 5 shows an inner race that has had a normal fatigue failure. The repeated loading and unloading of the race every time a roller passes eventually causes microscopic fatigue cracks to form under the surface.

In time, these cracks grow to the point where small portions of the surface flake off. This process is called "spalling" and the flaws left in the surface are called "spalls."

Figure 5. Normal Fatigue Failure

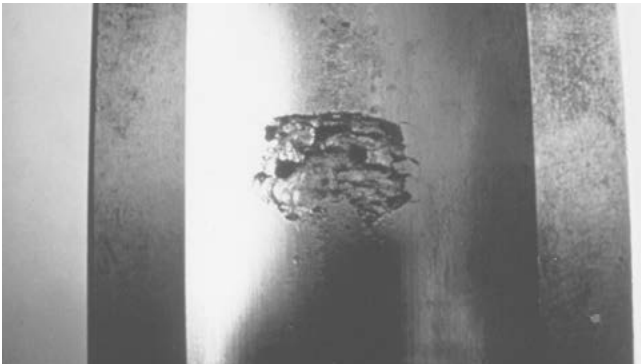
With continued operation, the spalls grow until the bearing becomes noticeably noisy. Figure 6 shows an inner race that has a severe spall. In addition to being noisy, it is also likely that this bearing would show high levels of vibration. The time required for the spalling to cause catastrophic bearing failure will vary with the load on the bearing and its speed. Usually the bearing will run for a while after it becomes noisy, but once noise is heard, prepare to have the bearing changed before it fails suddenly.

Figure 6. Spall

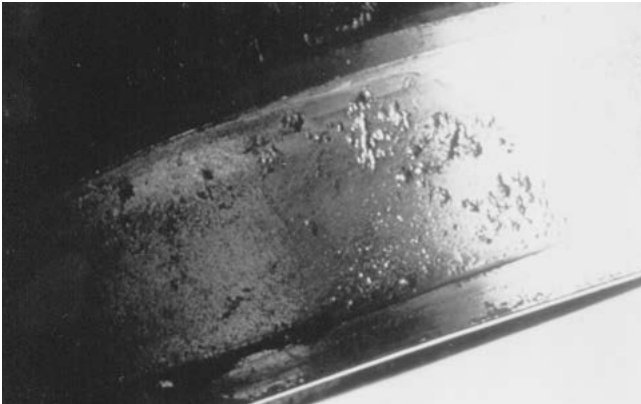
Inadequate lubrication can lead to spalling as seen in Figure 7. This bearing also shows signs of excessive

Figure 7. Spalls & Wear Patterns in the Race

wear due to inadequate lubrication. The rollers have worn a very deep wear pattern in the race.

Material that flakes out of spalls and other contaminants from other sources such as dirty grease or worn seals dents the races when caught between the rollers and races. Figure 13 shows an inner race with severe particle denting. Figure 7 also shows signs of particle denting. Each dent is a stress concentrator, which increases the stress in the area around the dent and accelerates the fatigue failure process.

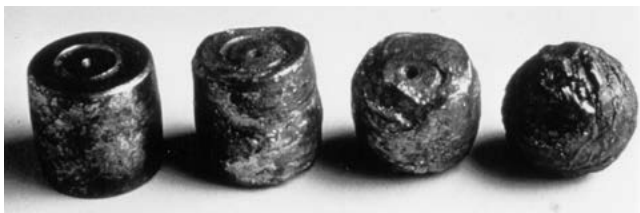
If the bearings continue to operate with inadequate lubrication, the evidence that shows this to be the mode of failure becomes destroyed. Notice how the spherical bearing rollers shown in Figure 9 become damaged with continued operation.

Figure 9. Damaged Spherical Bearing Rollers

If the bearing had been taken out of operation when the roller was in the condition shown on the left, it would be possible to determine the cause of failure. By the time the bearing completely failed, it had run so hot that the steel softened and the bearing became deformed. At this point it is impossible to tell what caused the initial failure. If you are having unexplained bearing failures, it is best to take the bearing out of service when you first notice noisy, hot or vibrating operation. The evidence showing the initial cause of failure is probably still visible and it will give you an idea as to what action to take to prevent additional failures.

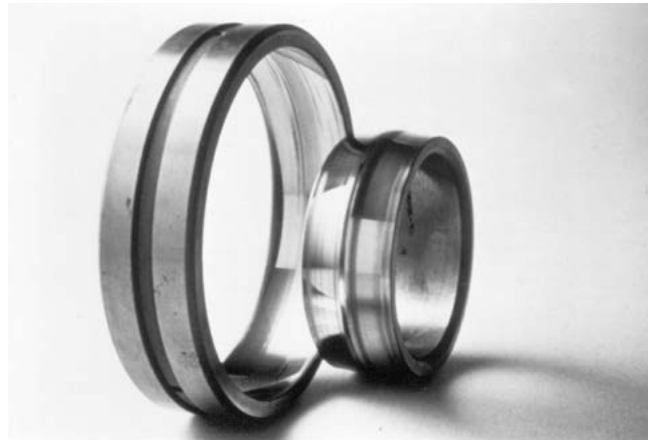
Figure 12. Highly Polished Surfaces Due to Inadequate Lubrication

Inadequate lubrication can sometimes cause the bearing surfaces to become highly polished as Figure 12 shows. Even though the surface looks nice, this is an indication of trouble. With continued operation the surface will change to a frosty appearance and eventually spall.

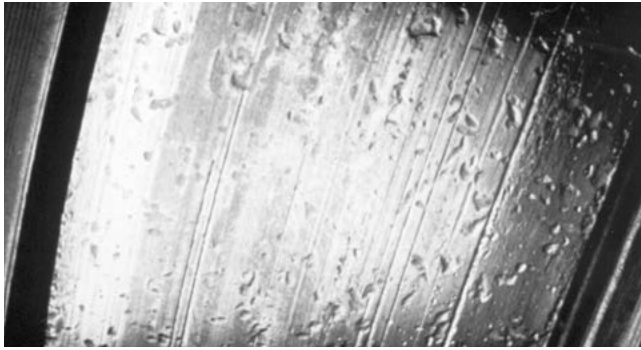
Figure 13. Severe Particle Denting

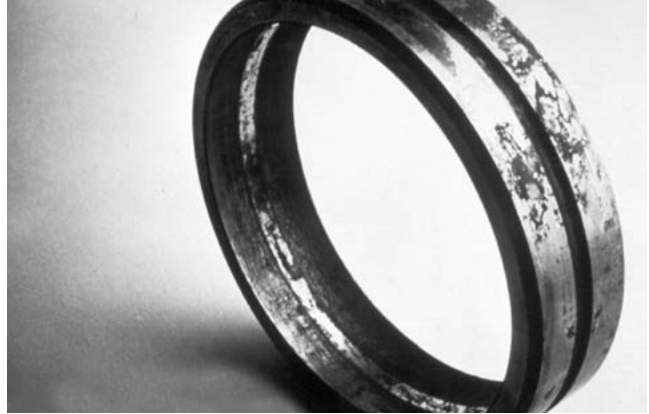
Keeping moisture out of bearings is necessary to achieve long life. Figure 14 shows a bearing severely damaged from water corrosion. This much damage was

probably due to seal failure, possibly in a “wash down” environment. High moisture applications require the use of grease that has rust inhibiting properties. Frequent relubrication is necessary, to insure that all bearing surfaces are coated with a protective layer of grease and that the rust inhibitors are replenished. Figure 15 shows a spherical roller bearing roller that has rusty ends from moisture in the lubricant.

Figure 14. Water Corrosion

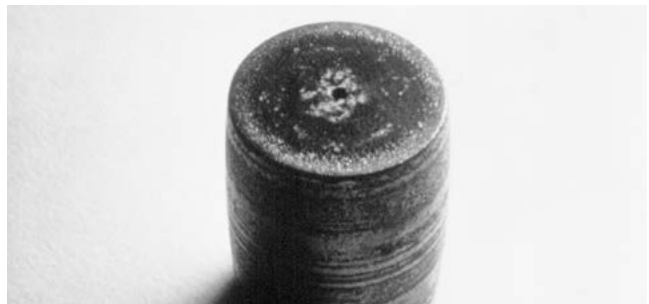
Figure 15. Bearing Roller with Rusty Ends Due to Moisture in the Lubricant

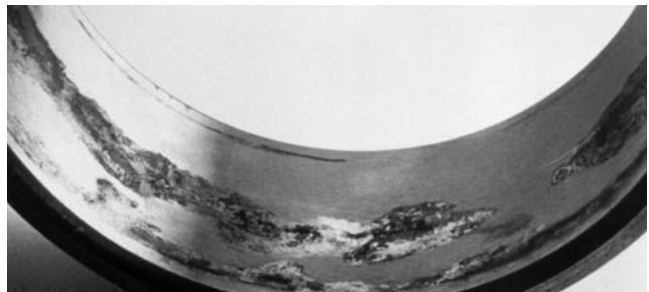
Water from condensation causes corrosion in idle fans. This is particularly true for fans in high moisture areas, located outdoors or improperly stored outdoors. Figure 16 shows an outer race damaged by puddle corrosion. Moisture or dew condensing in the bearing settles to the bottom of the race in puddles and causes rusting. Twin City Fan & Blower packs ball and unit roller bearings completely full of grease prior to shipment. Split pillow block spherical roller bearings are shipped with the bearing insert packed full. This minimizes the chances of having puddle corrosion occur during shipment and storage. This practice covers all components with grease and ensures there are no pockets of air where water can condense. At startup the excess grease purges out of the bearing, which gets a little messy but is better than having a damaged bearing.

Figure 16. Puddle Corrosion

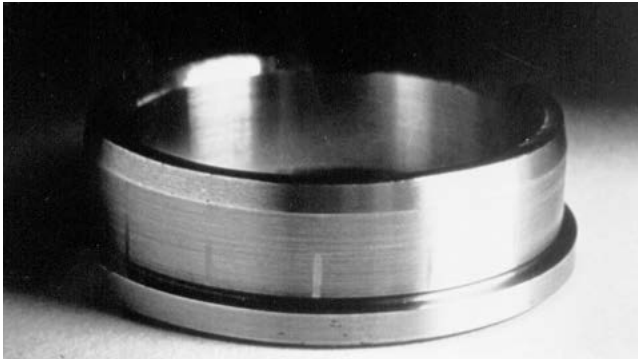
“True brinnelling” occurs when a bearing is subjected to impact and the rollers dent the races. Figures 18 and 19 show damage caused by improper mounting. Impact from hammering on the outer race or the bearing housing causes true brinnelling of the races. If it is necessary to tap on a bearing to get it into position, tap on the inner race so that the rolling elements do not carry the load. Dropping a bearing prior to mounting can also cause true brinnelling. Like false brinnelling, the marks are evenly spaced and the damage will eventually develop into spalls. Figure 20 shows spalls resulting from true brinnelling.

Figure 19. True Brinelling

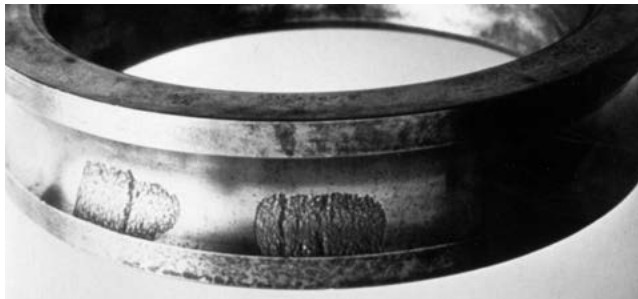
Figure 20. Spalls Resulting from True Brinelling

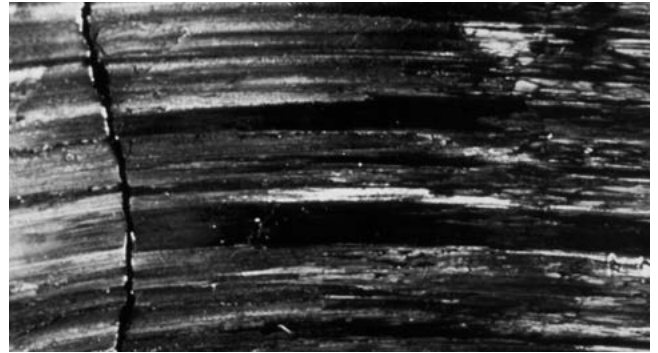
failures. Figure 22 shows the surface of a bearing bore that had too much clearance. The shaft turned in the bore, smearing the surface.

Insufficient tightening of the set screws on a set screw mounted bearing causes this type of failure. It can also be caused on a tapered adapter mounted bearing by not tightening the adapter lock nut enough. The damage to the surface resulted in a crack.

Figure 22. Smearing on a Bearing Race

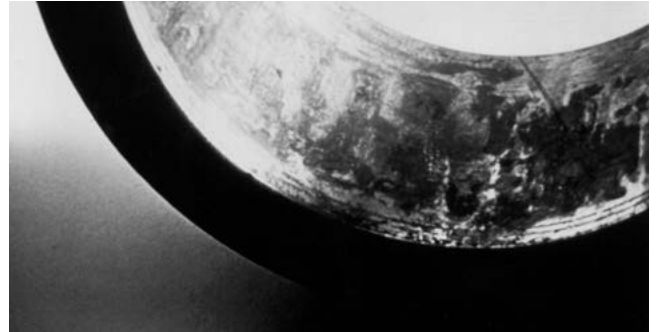
The bore of the bearing shown in Figure 23 shows signs of serious fretting corrosion. Microscopic movement between the shaft and the bore causes the rust colored patches to develop. Small amounts of fretting are common with set screw mounted bearings and are not detrimental to bearing life. Advanced cases, caused by loose mounting, can lead to cracks.

Figure 23. Fretting Corrosion on Bearing Bore

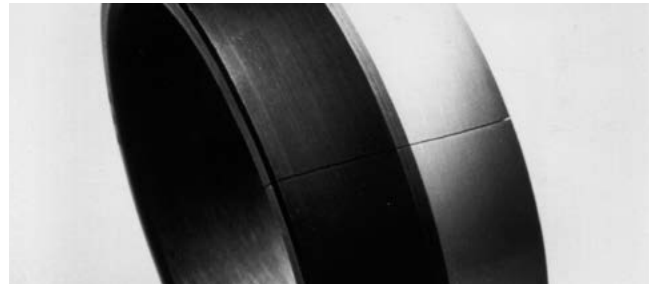
Tightening the locknut of an adapter mounted bearing too much can crack the inner race as shown in Figure 24 or the outer race as shown in Figure 25.

This also occurs by exposing the bearing on a high temperature fan to excessive temperatures. This easily happens when shutting down high temperature fans when they are hot or by exposing them to high temperatures while idle.

Figure 24. Cracked Inner Race

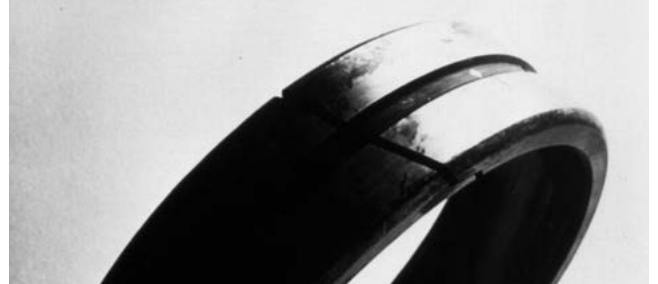
Figure 25. Cracked Outer Race

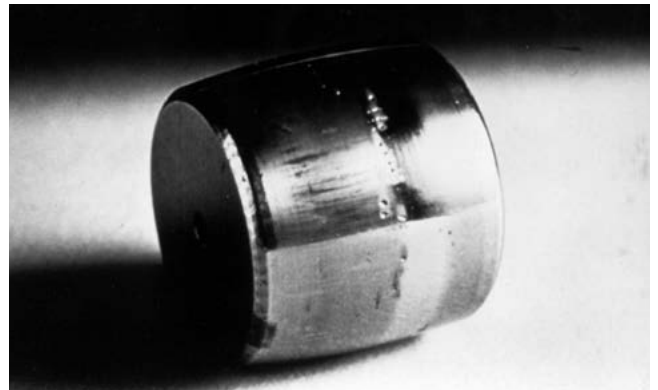
Figure 26. Pits Caused By Electrical Current

Allowing electrical current to pass through a bearing can cause damage. Figure 26 shows a spherical roller with pits in its surface caused by electrical current. This type of damage commonly occurs when welding balance weights on a fan impeller with improper grounding. To avoid having the welding electrical current pass through the bearings, attach the grounding clamp to the impeller or shaft when adding balance weights.
