Variable Frequency Drive (VFD) Induced AC Motor Shaft Current and Bearing Damage

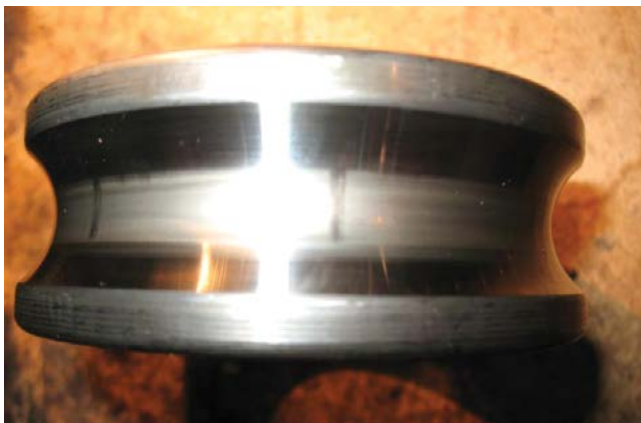
Figure 2. Bearing race exhibiting a "frosted" appearance.

In cases where induced shaft voltage exceeds the dielectric resistance of the bearing lubrication film, electric current will arc from the bearing ball or roller and raceway with sufficient amperage to create EDM pit. Due to the high frequency of the switching circuits, the electrical discharge arcs through the bearings can also occur at a high frequency. Even after a short period of time, the entire bearing race will become coated with small EDM pits. The inside surface of the bearing race will take on a "frosted" appearance. Eventually the bearing race will become severely pitted and fluted. Excessive noise and eventual bearing failure are the end results. Motor bearing failures have been documented after as little as a few months of operation. The majority of motor bearings that experience this issue will fail after 3 to 12 months of operation.

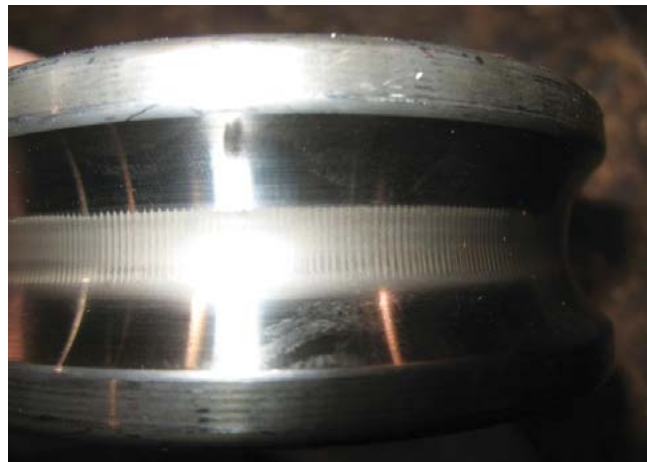
Figure 3. Bearing race exhibiting "fluting".

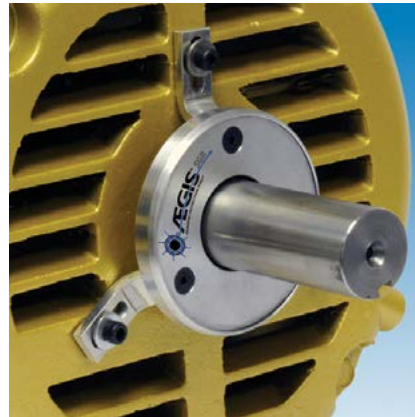
Figure 5. Externally mounting shaft grounding ring.

motor shaft), shaft grounding protects the motor against static electricity generated by the fan impeller. Grounding brushes have been proven to be effective, but require maintenance and are prone to failure due to wear. More recently, the shaft grounding ring (SGR) has been developed. The shaft grounding ring contains conductive microfibers that provide more points for conduction and are more durable than conventional brush fibers. A shaft grounding kit utilizing a shaft grounding ring can be installed to the motor shaft, grounding the motor shaft to the frame. Some AC motors may be purchased with shaft grounding rings pre-installed. In order for the shaft grounding ring to function effectively, the shaft must be cleaned before installation in order to ensure proper conductivity between the shaft and the grounding ring. Also, the motor must not be idle for an extended period of time as this may allow rust to build up on the shaft, causing the grounding ring to be ineffective. Internal installation is available on some motors, providing a cleaner environment and protection from damage for the shaft grounding ring. If the shaft is clean and free of rust, the combination of a shaft grounding ring and an insulated non-drive-end bearing provides excellent protection against EDM damage to bearings.
